Locations along Birch Stream (upstream to downstream)

Selected Problem Conditions (upstream to downstream)

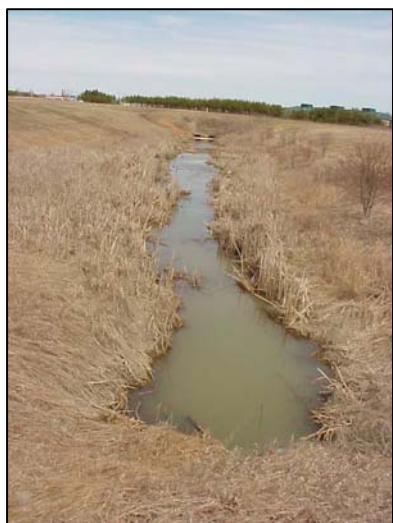
Fig. 7. Unshaded ditch in airport area (4/2005)

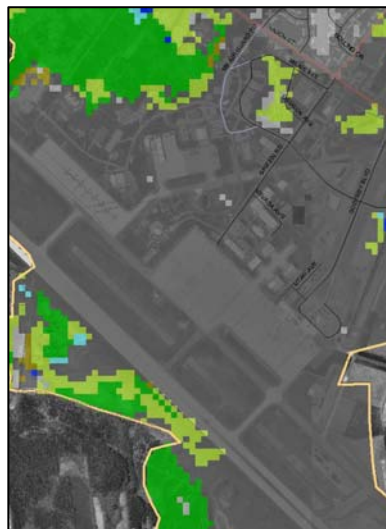
Fig. 8. Extensive impervious areas (gray) in upper watershed

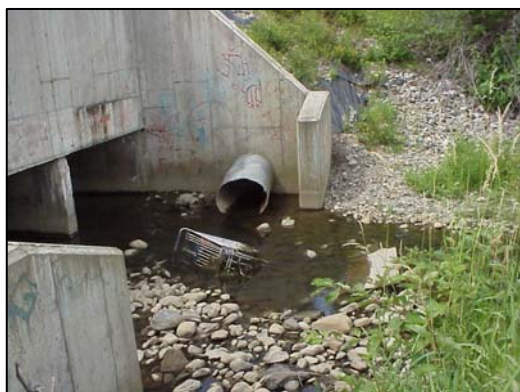
Fig. 9. Stormwater outfall below Airport Mall (8/2004)

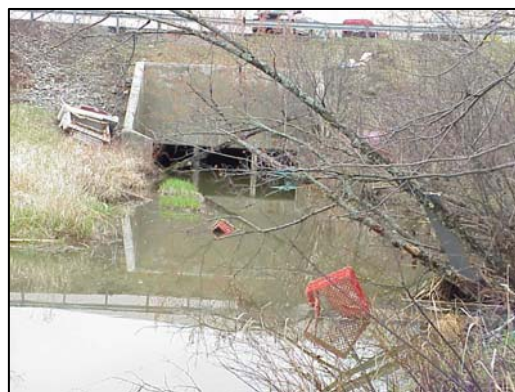
Fig. 10. Trash in stream, below Airport Mall (5/2003)

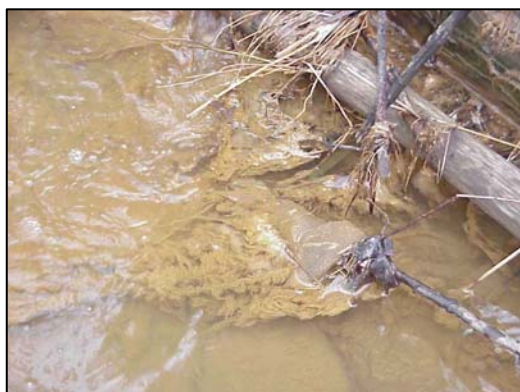
Fig. 11. Bacteria (*Sphaerotilus*) mats in stream (5/2003)

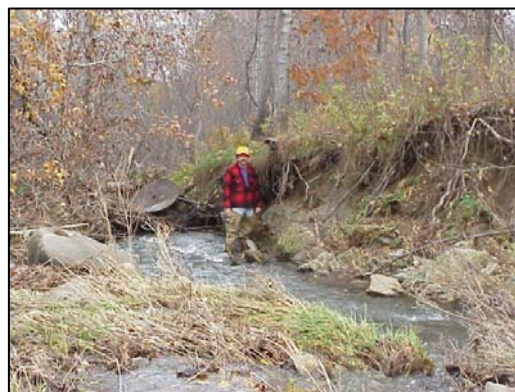
Fig. 12. Major erosion below Ohio Street (11/2003)
